REPORT No. 248

**THE CORROSION OF MAGNESIUM AND OF THE
MAGNESIUM ALUMINUM ALLOYS
CONTAINING MANGANESE**

By J. A. BOYER
American Magnesium Corporation

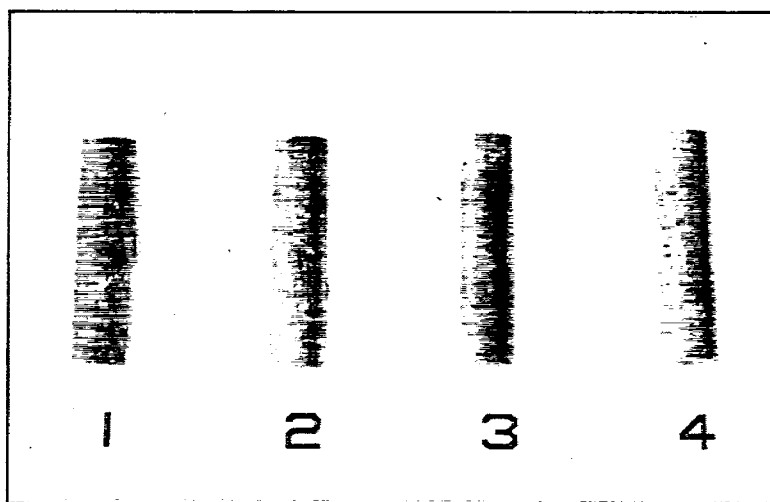
FIG. 1.—Machined pieces of magnesium after two months' immersion in salt solution. Specimens 1 and 2 immersed in 2 per cent NaCl solution. Specimens 3 and 4 immersed in 10 per cent NaCl solution

Corrosion tests of more than 50 specimens of magnesium ingot taken at random from stock have shown that pure magnesium is quite resistant to corrosion. Machined specimens immersed in salt solutions of various concentrations for a period of two months remained intact and usually showed very little pitting. Four pieces of magnesium after two months' immersion in salt solution are shown in Figure 1. The specimens were acid cleaned after removal from the corroding medium.

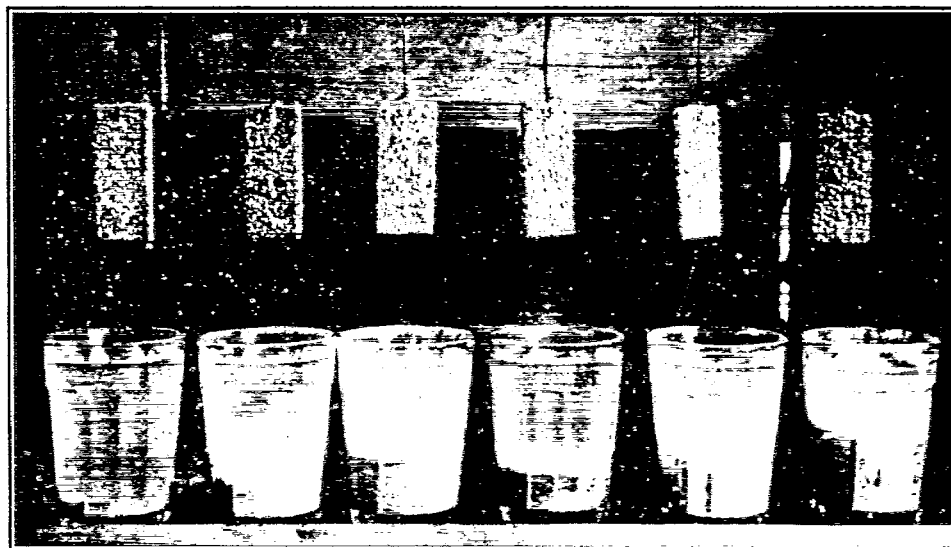
FIG. 2.—From left to right, 2, 3, 4, 5, 6, and 8 per cent aluminum, intermittent immersion, 2 per cent NaCl solution, 48 hours

With the addition of aluminum to magnesium the rate of corrosion increases enormously. A 4 per cent alloy of even half-inch thickness will be completely disintegrated in less than a week; the 8 per cent alloy corrodes even more rapidly. The effect of aluminum on corrosion is shown in Figure 2, which represents the result of a 48-hour intermittent immersion test, using 2 per cent sodium chloride solution.

Alloy	Loss in weight
<i>Per cent Al</i>	<i>Grams</i>
2-----	2.8
3-----	6.7
4-----	10.9
5-----	9.7
6-----	11.2
8-----	16.3

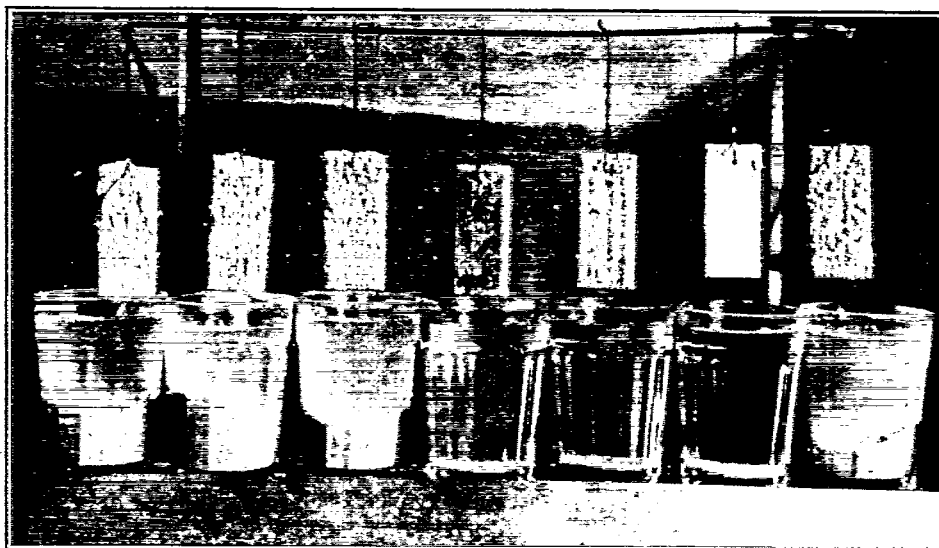
FIG. 3.—Specimens from left to right are numbers 1 to 7 of preceding table

It will be observed that the loss in weight of the aluminum alloys containing no manganese is from 20 to 30 times as great as with specimens 4, 5, and 6, which contain approximately three-tenths per cent manganese. The abnormal loss of the air cast specimen presented a problem for further investigation.

The alloy chosen was specimen No. 7 of the corrosion test shown in Figures 3 and 4. This alloy differed from the three resistant test specimens by being chill cast while the others were cooled fairly slowly; it was also air cast and contained included films, while the resistant alloys were vacuum cast; in addition, it was slightly low in manganese. It was believed that the examination to determine whether coring was the cause of corrosion would also determine the influence of the other two factors by a process of elimination.

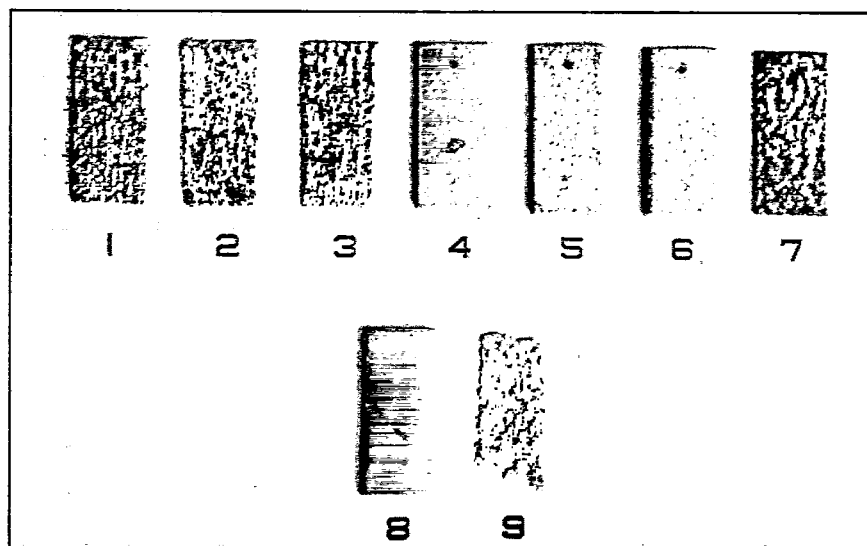
FIG. 4.—Specimens 1-7, same test as in Figure 3. Specimen 8, 4 per cent Al, 3 per cent Mn, and 9, 4 per cent Al in 10 per cent salt solution four days

A more striking illustration of the effect of manganese on the corrosion of the magnesium-aluminum alloys is shown in specimens 8 and 9 of Figure 4. The former is a 4 per cent aluminum alloy containing three-tenths per cent manganese, which has been immersed in a 10 per cent salt solution for four days. The specimen is scarcely pitted. Specimen No. 9 of the same composition except for the manganese, and immersed in the same strength salt solution for the same length of time, is almost completely disintegrated.

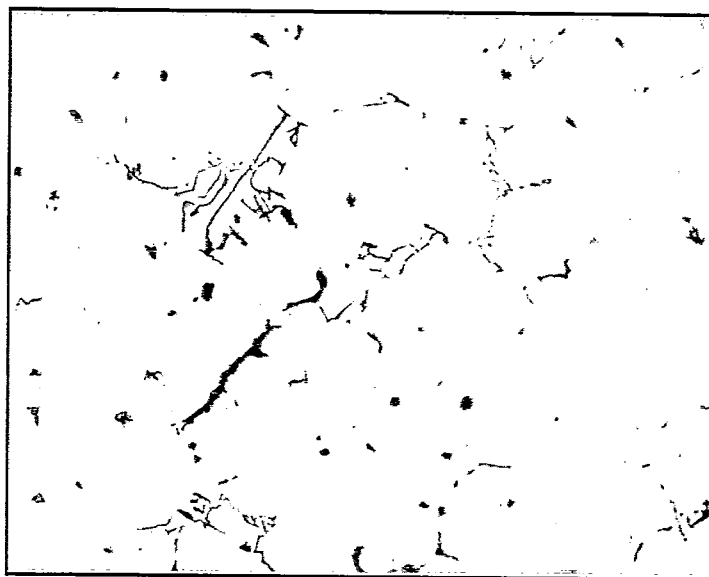
FIG. 5.—Mag. 100 X. Microstructure of an alloy fairly resistant to corrosion

Figure 5 shows the microstructure of an alloy which was comparatively resistant to corrosion. A considerable quantity of magnesium silicide was present and also a large number of small hard particles not definitely identified. These hard particles are usually present in the aluminum alloys and are believed to be due to iron.

The microstructure of the alloys varied between that shown in Figure 5 and that of Figure 6. Silicide and aluminum constituents were present, usually in small amounts, and under the microscope these constituents were found to be absolutely inactive. The hard particles in Figure 6 which were scattered through the alloys were also inactive unless the cathode areas might possibly be an occasional one of these particles. However, if such was the case it is estimated that not more than one out of fifty or a hundred were active. During the examination of these alloys literally thousands of these particles have been observed from which no hydrogen was liberated.

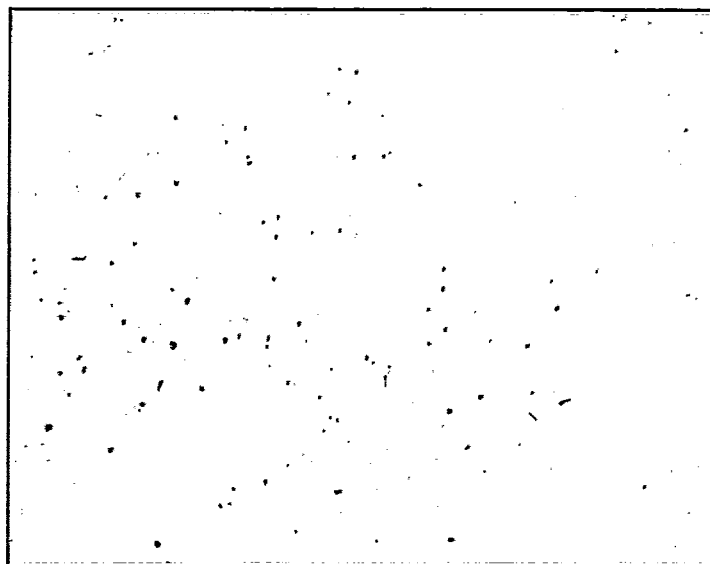
FIG. 6.—Mag. 100 X. Microstructure of an alloy which was completely disintegrated in a few days

Figure 6 shows the structure of an alloy which corroded rapidly and was completely disintegrated by salt water. It is more nearly homogeneous than the resistant alloy shown in Figure 5. The same hard particles are present but no appreciable amount of silicide was observed.

Silicide was not responsible for the inhibitive effect, as alloys having a microstructure almost identical with Figure 6 were also quite resistant.

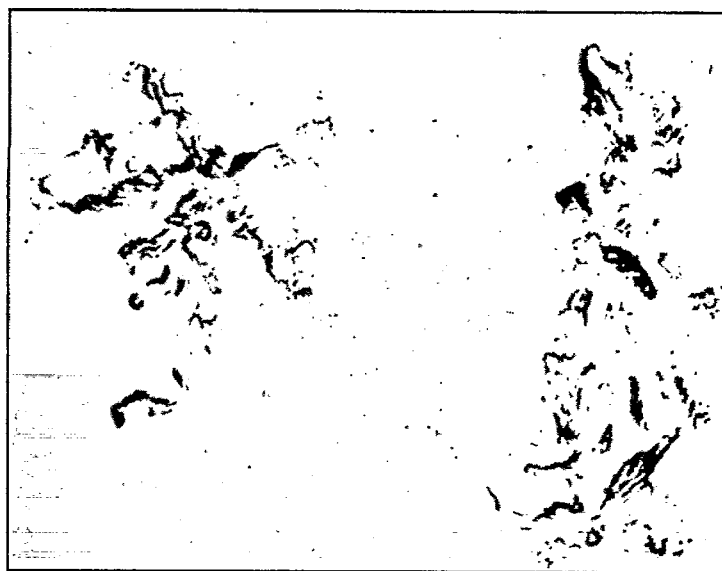
FIG. 10.—Mag. 100 X. Bottom of corrosion pits in a 3 per cent aluminum alloy showing the absence of undissolved constituent or segregated impurity

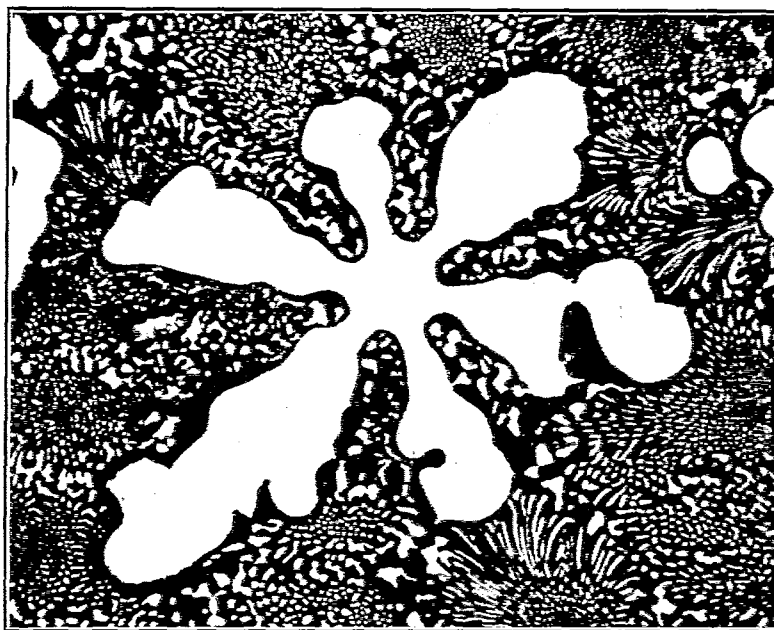
FIG. 11.—Mag. 100 X. Primary magnesium dendrite in an alloy containing 30 per cent aluminum

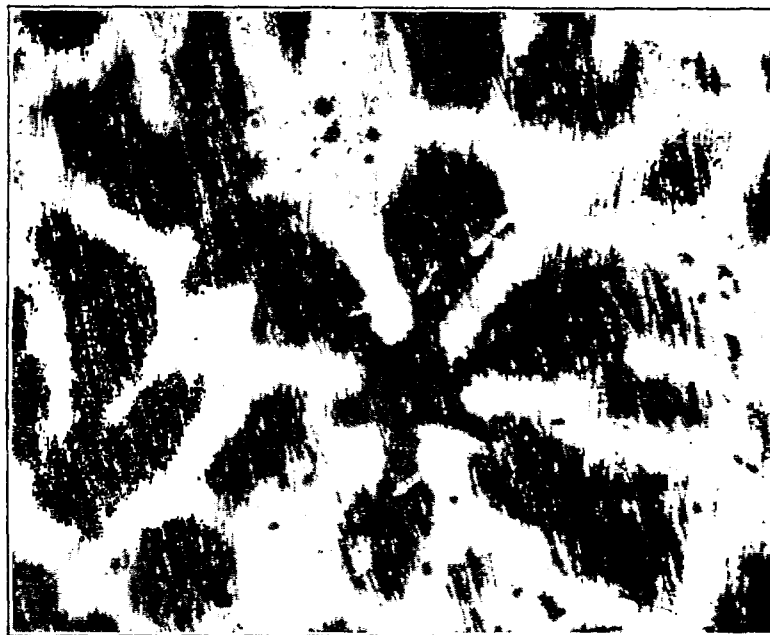
FIG. 13.—Mag. 100 X. Tarnish pattern on polished surface of solid solution alloy (3 per cent aluminum) after immersion in salt water. Compare with Figure 11

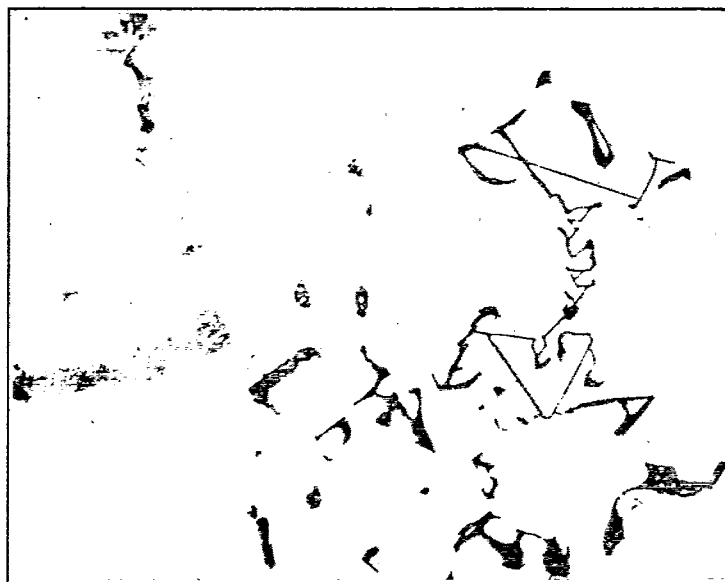
FIG. 15.—Mag. 200 X. Microstructure of an alloy containing 5 per cent aluminum, 0.3 per cent silicon, balance magnesium

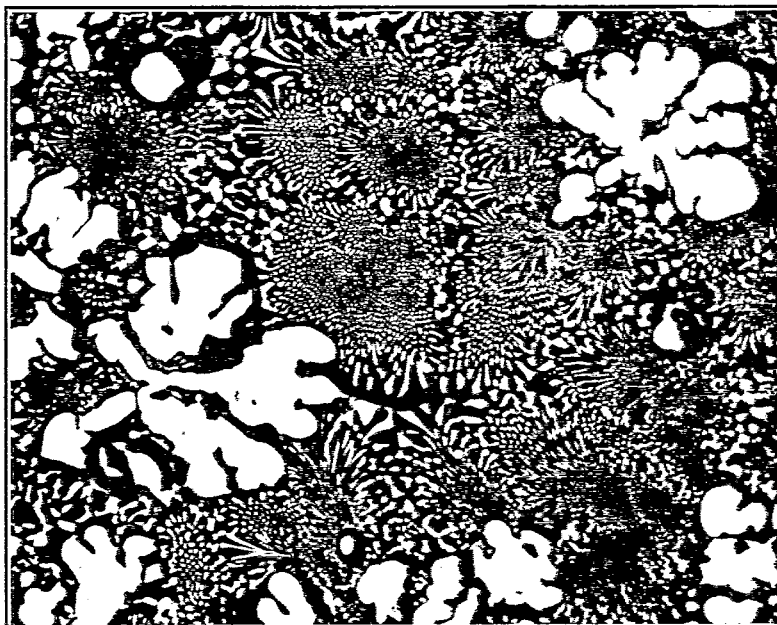
FIG. 19.—Mag. 100 X. Primary magnesium in an alloy containing 30 per cent aluminum

When these alloys were examined while immersed in salt water the type of corrosion was found to be identical with the purer magnesium-aluminum alloys containing only one constituent. There were numerous cathode areas, but the magnesium-rich dendrites were eaten out as before and the attack was practically independent of the distribution of undissolved constituents. This is shown in Figures 17 and 20. All specimens did not show perfectly formed dendrites, but there was usually a similarity between the form of the corrosion pit and that of primary magnesium, as illustrated in Figures 19 and 20.

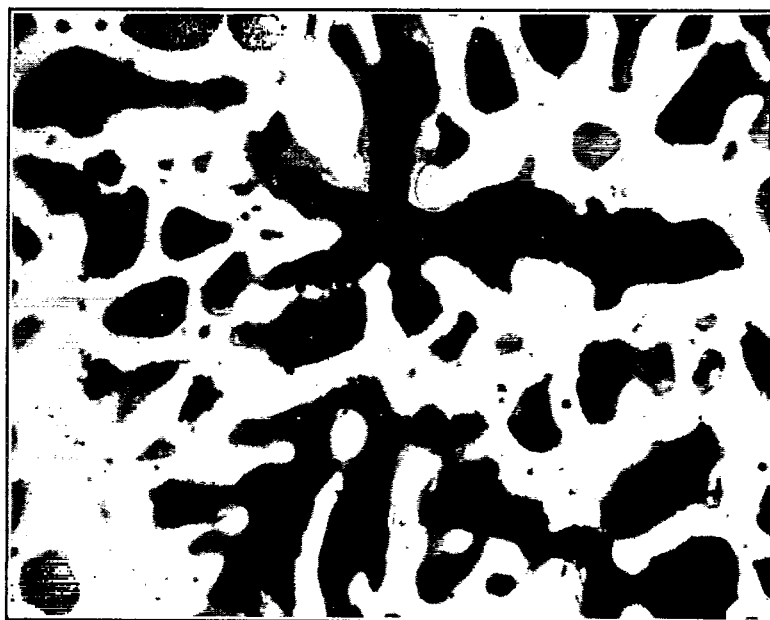
FIG. 24.—Mag. 100 X. Corrosion pits in the alloy of Figure 23. Specimen was repolished and etched after corrosion. Corrosion pits black; cored dendrites halftone

When the specimens which had been corroded in salt water and then repolished to remove the tarnish film were etched to bring out the cored structure it was found that the corrosion pits were superimposed on the magnesium-rich cores, as shown in Figure 24.

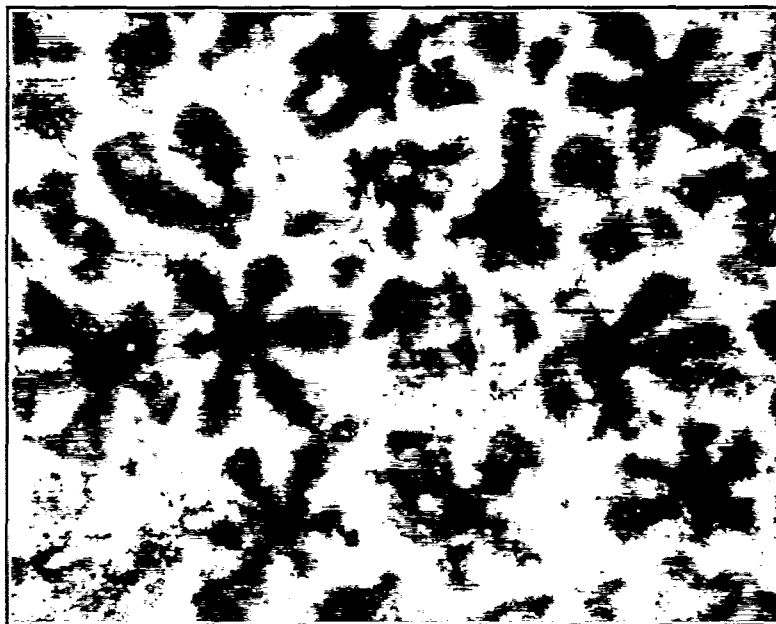
FIG. 25.—Mag. 100 X. Tarnish pattern of magnesium-aluminum alloy containing 0.3 per cent manganese

The tarnish pattern brought out by the action of salt water showed that manganese did not change the dendritic structure of the magnesium-aluminum alloys (fig. 25). The type of corrosion was similar to that of the binary alloys without manganese, except that the tarnished dendrites did not have as great a tendency to be eaten out. The cored structure would also be developed by etching, as shown in Figure 26.

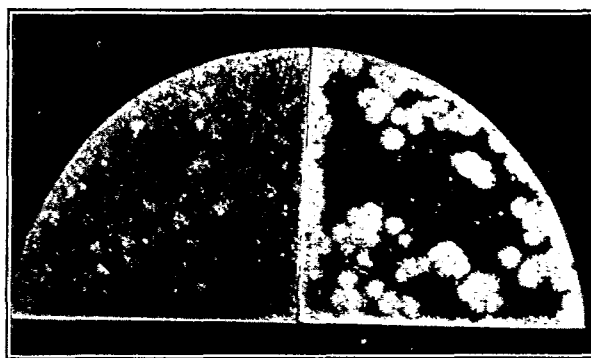
FIG. 28.—Same specimen as Figure 27. Left half as cast; right half annealed five days at 400° C.

Figure 28 shows the two halves of the specimen, the left half as cast and the right half annealed for five days at 400° C. In the heat-treated specimen the dendritic attack, running from the outer edge in tree-like fashion, was absent but it appeared that whole grains were eaten out. Resistance to corrosion was not bettered. When extruded pieces of the same alloy were given a similar heat treatment and tested quantitatively for corrosion they were found to even be worse than before heat treatment.

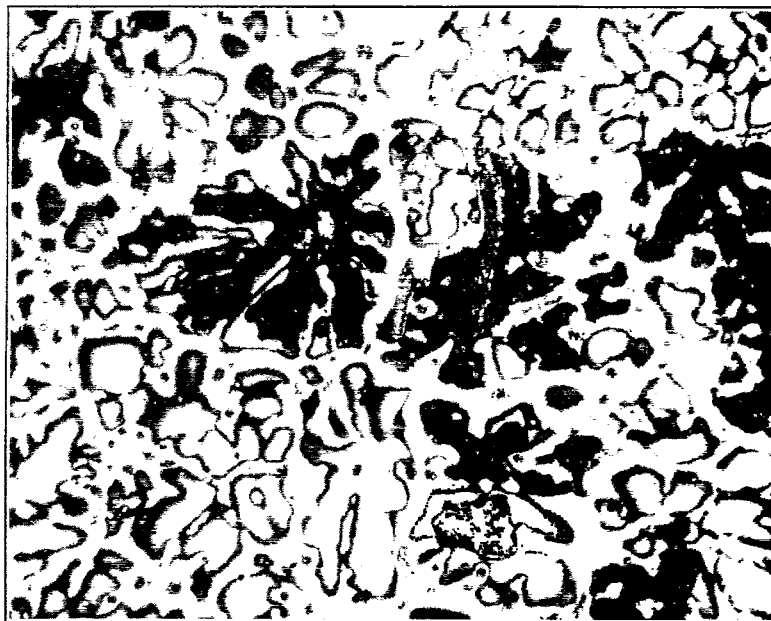
FIG. 31.—Mag. 100 X. Corrosion in area containing inclusions, showing relation between pitting and cored structure

dendrite loses its symmetry and tends to branch out at right angles from the edge of the inclusion to which it is attached. When the specimen is immersed in salt water the magnesium-rich cores are attacked, leaving the inclusion surrounded by a corrosion pit. This type of corrosive action is illustrated in Figure 31.

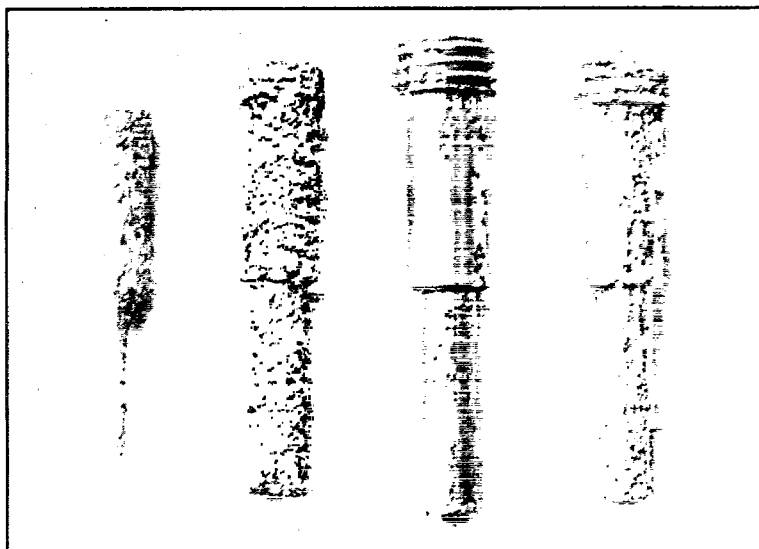
FIG. 32.—Effect of varying the manganese content of the 4 per cent aluminum alloy

1. 0.10 per cent Mn

A series of corrosion tests was made to determine the effect on corrosion of varying the manganese content of the 4 per cent aluminum alloy. The specimens were test bars which had been previously broken in tensile tests, and were machined to present a clean surface. A 2 per cent sodium chloride solution was used, and the results after five days' immersion are shown in Figure 32.

It is evident from these tests that a critical amount of manganese is necessary to produce a maximum inhibiting effect. The alloys low in manganese were badly corroded. A few hundredths of a per cent will make all the difference between an alloy which corrodes rapidly and one which is resistant. In order to determine more accurately the effect of small variations, a series of alloys was made in which the manganese was varied by approximately .05 per cent intervals. The specimens were the standard corrosion test pieces, $3 \times 1\frac{1}{8}$ inches $\times \frac{3}{16}$ inch. After five days' immersion in 2 per cent sodium chloride solution the pieces were acid cleaned and weighed.

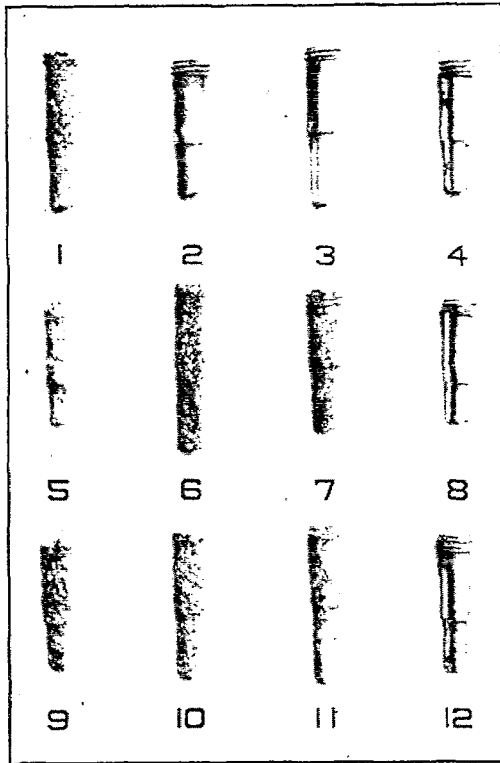
FIG. 33.—Corrosion tests of 6 per cent aluminum alloy containing varying amounts of manganese.

Spec. No.	Al	Mn
1	6.18	0.10
2	6.60	.20
3	5.91	.35
4	6.1	.57

Tests similar to those made with the 4 per cent aluminum alloy were run with alloys containing 6, 8, and 12 per cent aluminum. The results are shown in Figures 33 to 35. The specimens were ends of broken test bars which were machined again to present a fresh surface, and all samples were immersed for 48 hours in 2 per cent sodium chloride solution. At the conclusion of the test the specimens were acid cleaned by dipping for 20 seconds in dilute nitric acid.

The photographs of the 6 and 8 per cent series show the extent to which corrosion was inhibited in the specimens containing sufficient manganese. The effect is not brought out as well in the 12 per cent series because the latter are turned black on acid cleaning and do not present a polished surface. On visual examination after corrosion the 12 per cent alloy specimens 6, 12, and 18 were found to be unattacked by salt water except for a black surface discoloration.

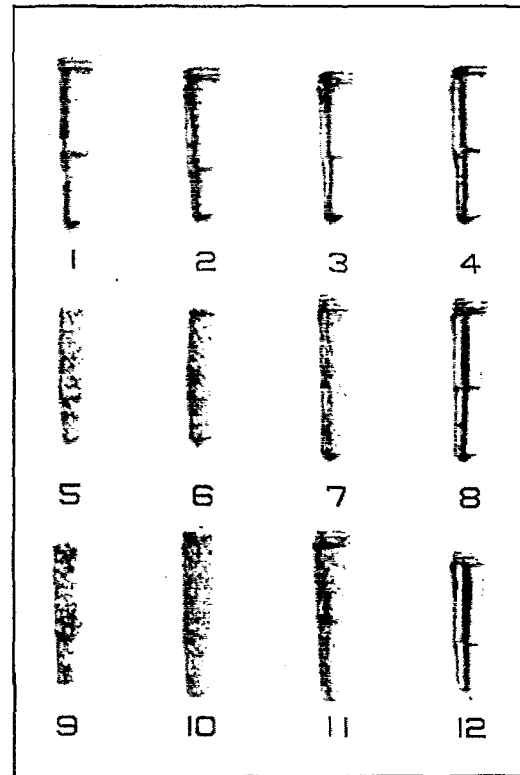
FIG. 34.—Corrosion tests of 8 per cent aluminum alloy containing varying amounts of manganese

Spec. No.	Al	Mn
1	8.61	0.12
2	7.86	.17
3	8.49	.42
4	8.18	.55

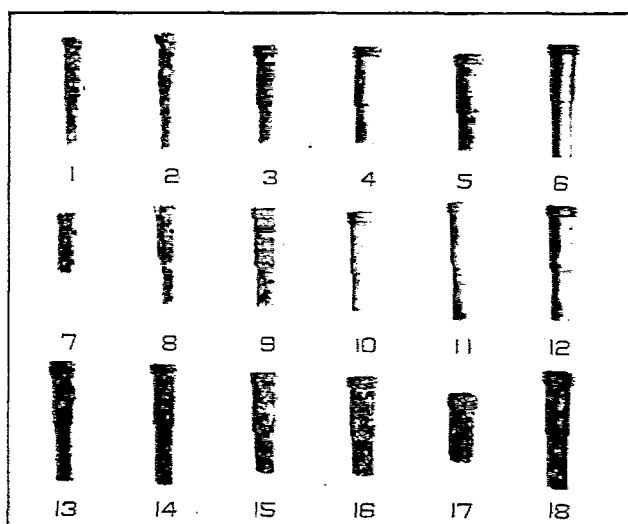
FIG. 35.—Corrosion tests of 12 per cent aluminum alloy containing varying amounts of manganese

Spec. No.	Al	Mn
1	12.05	0.08
2	12.54	.11
3	12.75	.20
4	12.76	.33
5	12.88	.51
6	12.38	.83

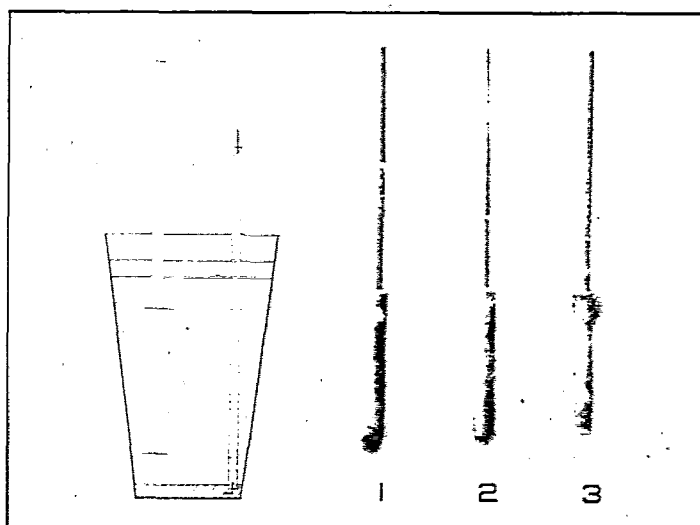
FIG. 36.—Electrolytic cell and electrodes used in overvoltage experiment. (1) Immersed in 10 per cent NaCl solution 7 days. (2) Connected to mercury 48 hours. (3) Connected to platinum 48 hours

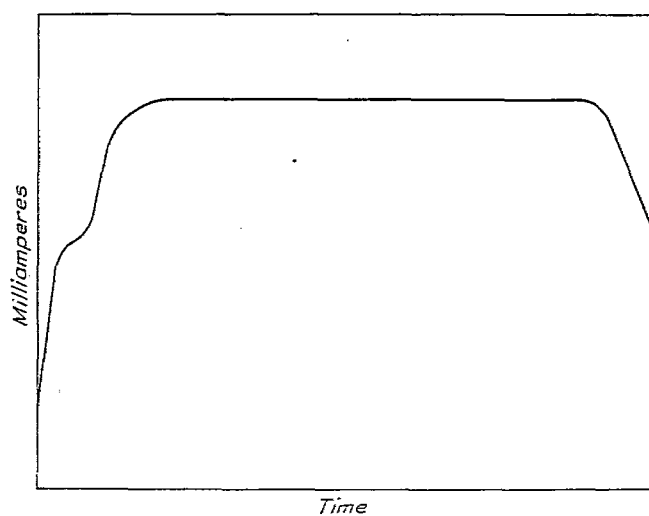
FIG. 37.—Current. Time curve for electrode connected to platinum

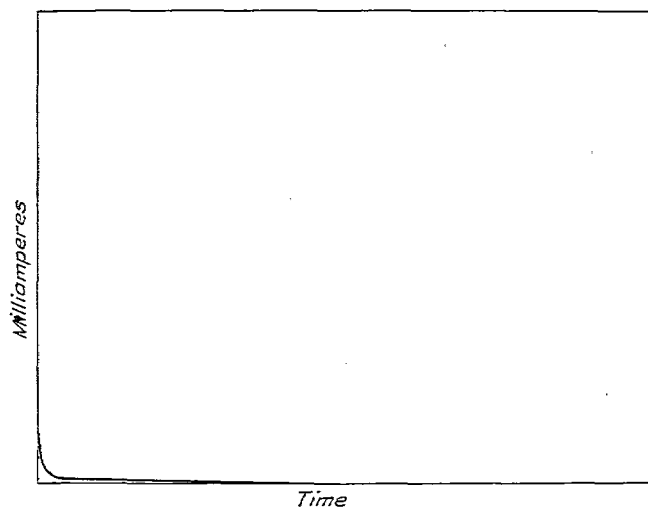
FIG. 38.—Current. Time curve for electrode connected to mercury

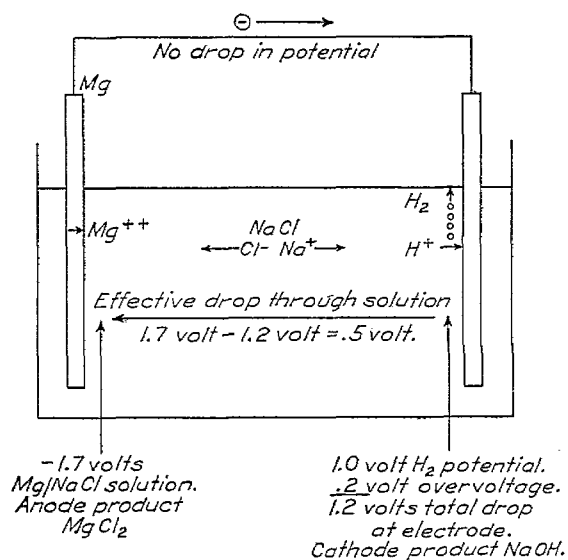
FIG. 39.—Diagrammatic representation of galvanic action with impurity of low overvoltage

The electrolytic corrosion cell is short circuited and there is practically no drop in potential through the metal. Thus the second metal or impurity tends to assume practically the same high potential as the magnesium. However, if the overvoltage is low, it can not keep this potential with respect to the solution, for hydrogen will plate out before the potential can be built up to this value. The impurity then functions not as a metal electrode but as a hydrogen electrode. If the impurity has no overvoltage it assumes practically the true hydrogen potential. If it has approximately two-tenths volt overvoltage it will assume a potential two-tenths volt higher than this. If the overvoltage equals or is greater than that of the reactive metal no current will flow unless the potential of the reactive metal is high enough to displace hydrogen on its own surface. Under any condition there is only a few tenths of a volt difference in *effective* potential between magnesium and the impurity. This effective potential difference may even be zero, whereas the difference in potential on open circuit may be from one to two volts.

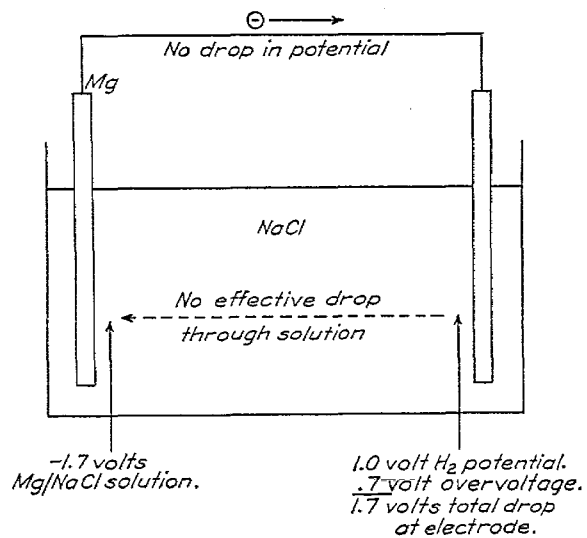
FIG. 40.—Diagrammatic representation of galvanic action with impurity of high overvoltage
